DEPARTMENT OF TRANSPORTATION

Contract #: 04-0120F4Cty: SF/ALA Rte: 80 PM: 13.2/13.9File #: 99.28**WELDING INSPECTION REPORT****Resident Engineer:**Siegenthaler, Peter**Address:** 333 Burma Road**City:** Oakland, CA 94607**Report No:** WIR-021441**Date Inspected:** 28-Feb-2011**Project Name:** SAS Superstructure**OSM Arrival Time:** 700**Prime Contractor:** American Bridge/Fluor Enterprises, a JV**OSM Departure Time:** 1900**Contractor:** Zhenhua Port Machinery Company, Ltd (ZPMC) Chanxing Island**Location:** Shanghai, China**CWI Name:** Mr. Qui Wen**CWI Present:** Yes No**Inspected CWI report:** Yes No N/A**Rod Oven in Use:** Yes No N/A**Electrode to specification:** Yes No N/A**Weld Procedures Followed:** Yes No N/A**Qualified Welders:** Yes No N/A**Verified Joint Fit-up:** Yes No N/A**Approved Drawings:** Yes No N/A**Approved WPS:** Yes No N/A**Delayed / Cancelled:** Yes No N/A**Bridge No:** 34-0006**Component:** OBG Segment**Summary of Items Observed:**

WELDING INSPECTION REPORT

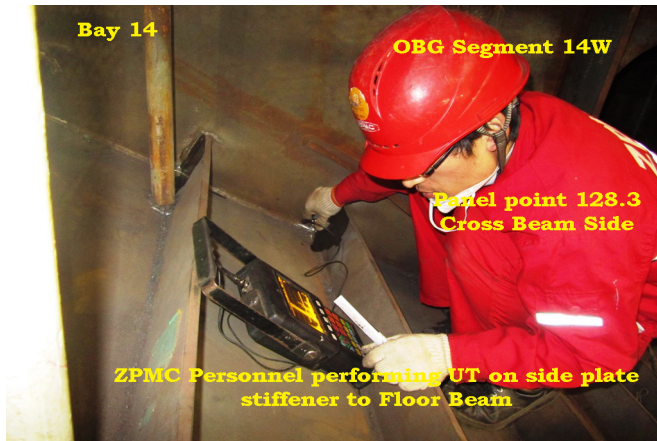
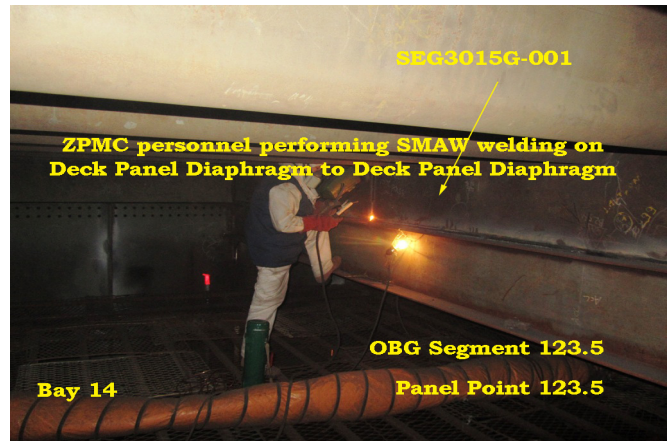
This QA inspector observed ZPMC personnel performed Ultrasonic Testing on Side Plate I-stiffeners to Floor Beam 'T' joint weld at panel point 128.3 of OBG Segment 14W. See the attached pictures.
